UNIVERSITY
OF MIAMI
DEPARTMENT of PSYCHOLOGY

SAFETY MANUAL

**University of Miami Department of Psychology
MRI Facility**

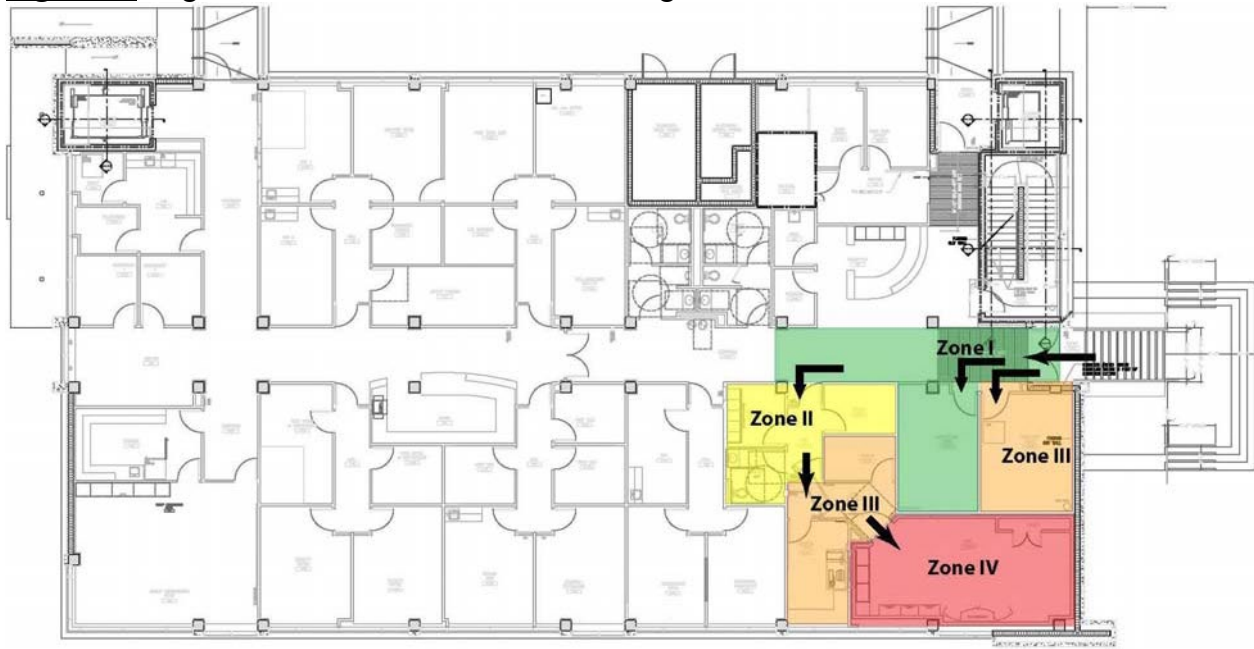
Figure 2. Diagram of the fMRI suite and zone designations.

The MRI suite houses a 3T MRI scanner; therefore, the ground floor has several zones that correspond to the safety levels associated with the 3T magnet. Entrance to the different zones is controlled to maintain a secure environment for research participants and staff.

Zone I is freely accessible by individuals working in the building. No special screening is required to be in Zone I.

Zone II is designated for pre-screening. Zone II includes two separate areas. One area is intended for simulation of the scanning procedures via mock scanner (Room 104C). The second area is intended for research participants reporting for research scans and consists of a waiting area, dressing room and restroom. Zone II is accessed from the reception/waiting area and is controlled by card reader access. Access is granted to personnel after completing the necessary safety training. All individuals participating in a research scan must complete a metal screening form and sign a pregnancy release form in Zone II before undergoing an MR scan.

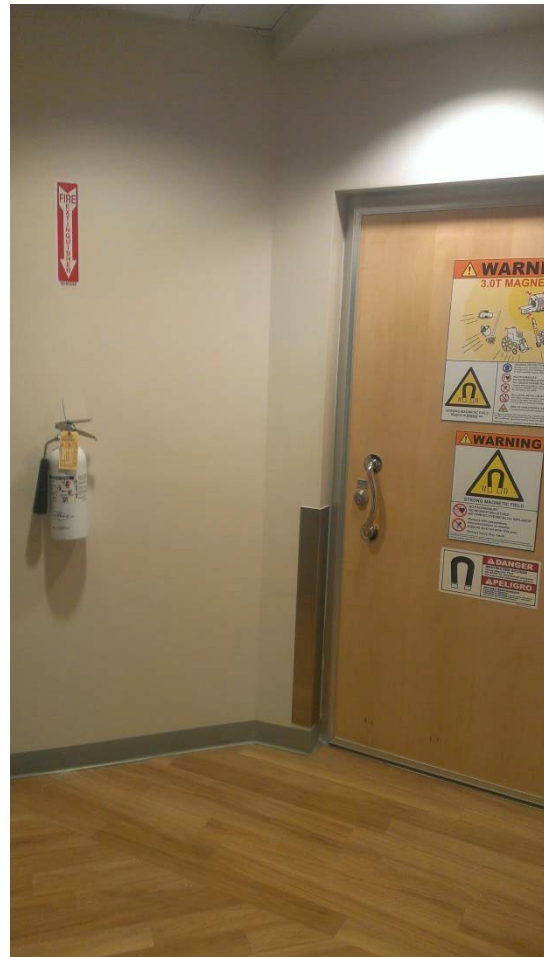
Activate the fire alarm system in the building

Press the emergency stop button that will disable all electrical power to the scan room.

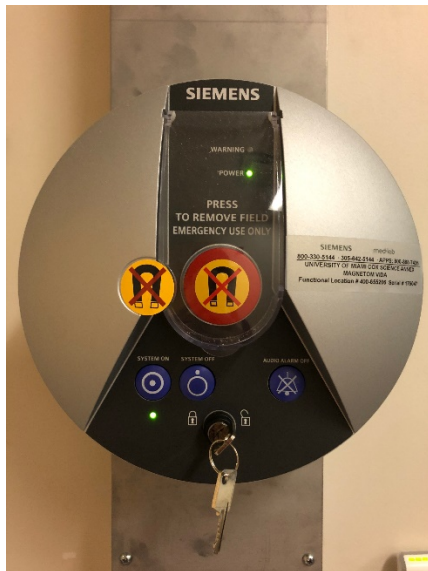
Figure 4. Quench button in the control room.

1. Use the intercom to alert the patient to stay calm and remain on the table until the operator gains access to the room to offer assistance.
2. Prop open the magnet room door to promote air circulation.
3. Transport the patient out of the room.
4. Evacuate all personnel from the area.
5. Inform the director and call the GE service engineer.

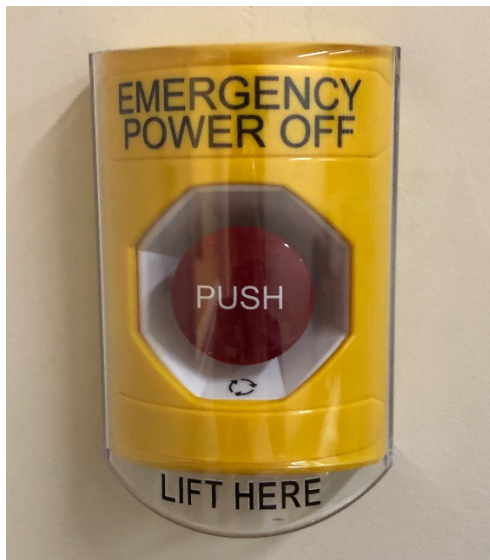
The **Emergency Off** button (pictured below) is on the operator's console, and there is also one in the scanner room. It removes ALL electrical power from the MRI console and the patient table, including any power sources from the Uninterrupted Power Supply (UPS) devices. The effect of pushing the Emergency Off button is to turn off the entire MR system EXCEPT for the static magnetic field and the magnet rundown unit (described below). This DOES NOT produce a quench.

The button should be used only to stop a scan during a patient emergency or during a serious equipment fault or hazard, such as fire or water in the vicinity of the MR equipment.

Figure 5. Emergency Off Button in the control room.
